DEPARTMENT OF TRANSPORTATION**DIVISION OF ENGINEERING SERVICES**

Contract #: 04-0120F4Cty: SF/ALA Rte: 80 PM: 13.2/13.9File #: 69.28**WELDING INSPECTION REPORT****Resident Engineer:**Siegenthaler, Peter**Address:** 333 Burma Road**City:** Oakland, CA 94607**Report No:** WIR-018603**Date Inspected:** 09-Dec-2010**Project Name:** SAS Superstructure**OSM Arrival Time:** 700**Prime Contractor:** American Bridge/Fluor Enterprises, a JV**OSM Departure Time:** 1900**Contractor:** Zhenhua Port Machinery Company, Ltd (ZPMC), Changxing Island **Location:** Shanghai, China**CWI Name:** Li Yang**CWI Present:** Yes No**Inspected CWI report:** Yes No N/A**Rod Oven in Use:** Yes No N/A**Electrode to specification:** Yes No N/A**Weld Procedures Followed:** Yes No N/A**Qualified Welders:** Yes No N/A**Verified Joint Fit-up:** Yes No N/A**Approved Drawings:** Yes No N/A**Approved WPS:** Yes No N/A**Delayed / Cancelled:** Yes No N/A**Bridge No:** 34-0006**Component:** OBG Segment**Summary of Items Observed:**

OBG # TRIAL ASSEMBLY YARD (11EW-12AW)

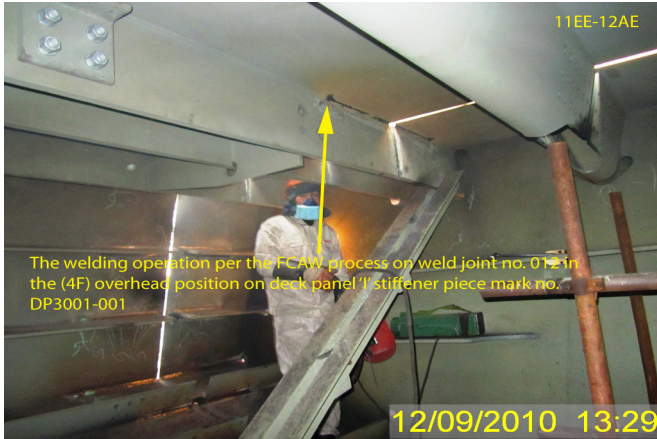
The QA Inspector observed the welding operation per the FCAW process on weld joint no. 013 in the (4F) overhead position on deck panel 'I' stiffener piece mark no. DP708-001. The location was the hold back of 'I' stiffener fillet weld of segment 11EE. The welder ID was 040320. The ZPMC CWI was identified as Li Yang. The welding variables recorded by QC appeared to comply with the WPS-B-T-4114-1.

The QA Inspector observed the welding operation per the FCAW process on weld joint no. 012 in the (4F) overhead position on deck panel 'I' stiffener piece mark no. DP3001-001. The location was the hold back of 'I' stiffener fillet weld of segment 12AE. The welder ID was 040320. The ZPMC CWI was identified as Li Yang. The welding variables recorded by QC appeared to comply with the WPS-B-T-4114-1.
For additional information please reference the pictures below:
